Sample Report

Property address Drury

Inspection date 2/5/12

Property description Split level, 4 bedroom, 2 bathroom, brick cladding, pressed metal tile roof house

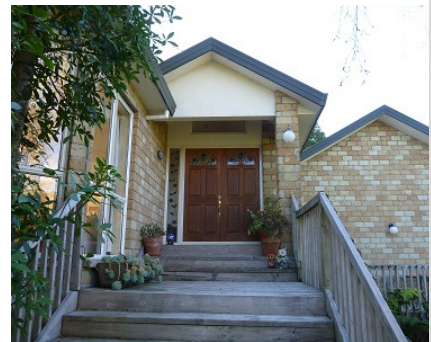
There is a timber deck and stairs up to the front door and is good condition with all handrails securely fixed, photo 3

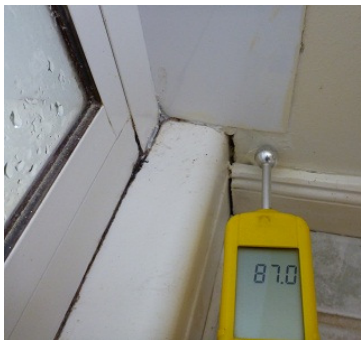
Acrylic tray and liners with a glass door. No sign of any water egress. Slightly above normal Moisture Meter readings around 1 corner of the ensuite shower. Reading 87 approx. 40 %. Keep an eye for leaks. Possibly could reseal shower	1
Toilets

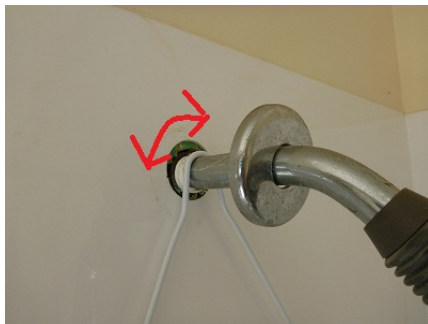
Flick mixer type, work ok. The bathroom shower head connection in the wall turns when you try to adjust the shower head, this shouldn't happen. It does not leak	2

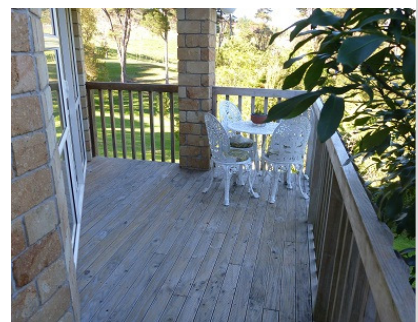
There are timber decks off 2 bedrooms and both are in good condition with handrails all secure, photos 2 & 3

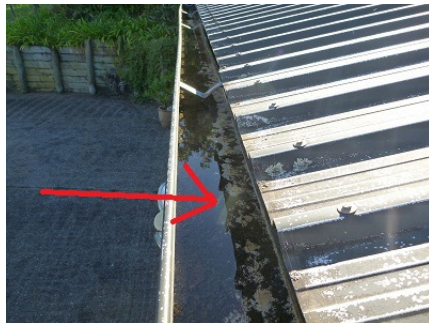
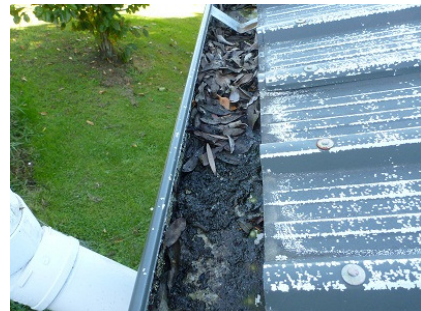
Garage					
	<div><div></div><div></div><div></div></div>		Details	Photo ref	
Internal door	<div><div></div><div></div><div></div></div>		Nil		
External door	<div><div></div><div></div><div></div></div>		Single aluminium door and ranchslider, work ok.		
Garage door	<div><div></div><div></div><div></div></div>		2 Tilta type motorised doors, work ok.		
Walls	<div><div></div><div></div><div></div></div>		Exposed timber	1	
Ceiling	<div><div></div><div></div><div></div></div>		Exposed trusses	1	
Floor coverings	<div><div></div><div></div><div></div></div>		Concrete		
Windows	<div><div></div><div></div><div></div></div>		Work ok.		
Cladding	<div><div></div><div></div><div></div></div>		Walls= Colorsteel weatherboards in good condition Roof= Longrun iron in good condition Gutter= needs cleaning on the back side and water was sitting in the front one, fall not right	2,3	
Photo one		Photo two		Photo three

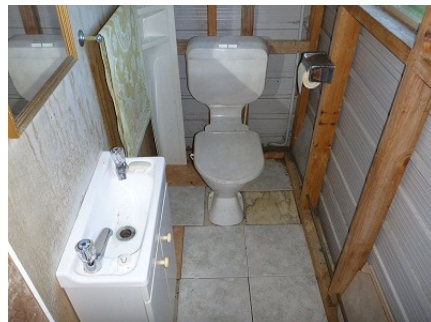
There is a toilet and small vanity in the garage and are in good working order, photo 4

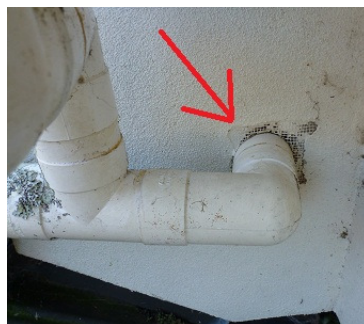
Photo one

Brick. Had a small amount of 40mm plaster polystyrene up on some internal walls on the roof. Recommend sealing around 1 downpipe as there are gaps where the pipe goes through	1
Joinery

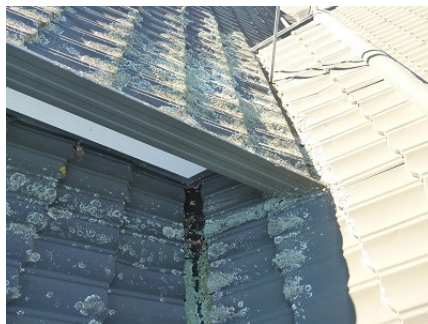
Photo two

Pressed metal tile in good condition. Needs cleaning in as places as Lichen is heavily built-up	2
Roof slope

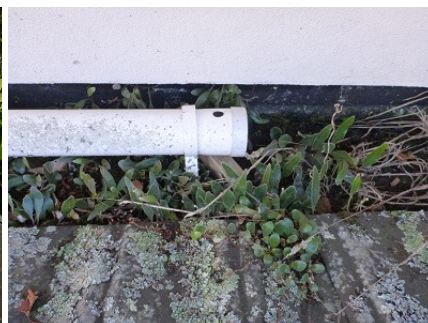
Photo five

PVC and butynol internal guttering. Butynol gutters in need of cleaning, plants and moss growing	5
Eaves Downpipes

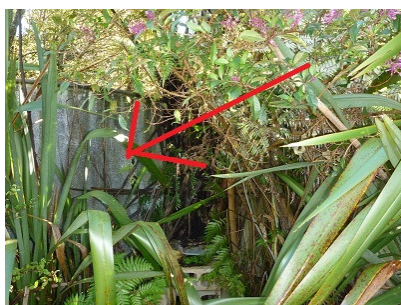
There are 2 concrete water tanks installed, it was hard to get a good look at them but appeared to be in good condition i.e. no sign of any major cracking, photo 6

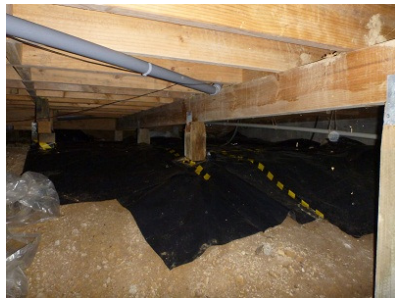
Additional notes					
There was some polythene laid over some of the dirt, photo 3. Being flat water can sit there and this prevents rising

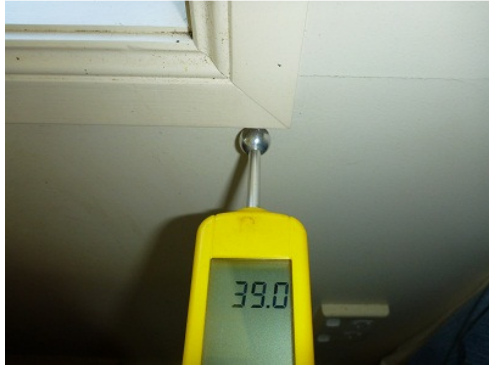
General reading throughout

Moisture testing was carried throughout inside using a non invasive meter and readings came back within desired levels. Under 40 (approx. 15-20%) is acceptable.

Just 1 slightly elevated reading in 1 corner of the ensuite shower
