**76 Gracechurch Dr,
Flat Bush**

Inspection date 6/5/16

Property description 2 storey, 5 bedroom, 4 bathroom, brick and plaster cladding, concrete tile roof house

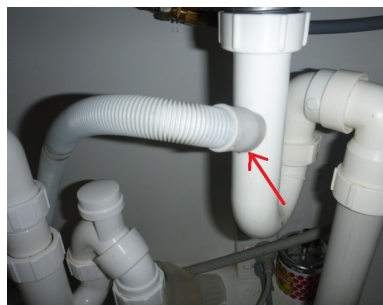
Traps checked and no sign of leaks Recommend a ring clamp on the dishwasher waste pipe that connects onto the sink trap, can vibrate off	1
Photo one		Kitchen			Photo three

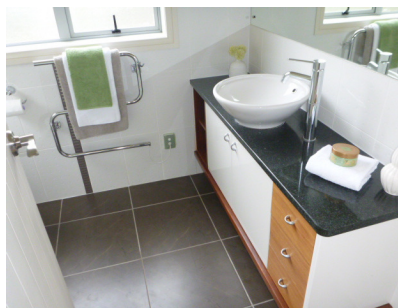
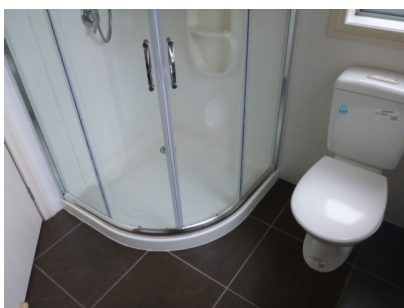
Acrylic tray and liner with a glass, no sign of any leaks. Master bedroom shower doors are a little stiff to open and close and 1 handle is loose	
Toilets

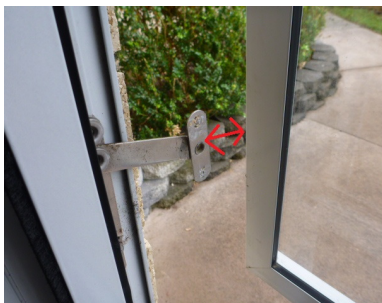
All work ok. 1 restrictor stay has come loose on a window, needs re-installing	1
Heating				Gas fire, not tested	
Photo one		Family		Lounge

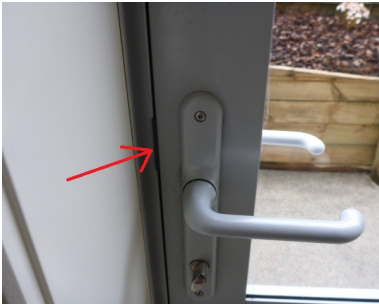
Single aluminium door. Door hits around the lock area, needs easing	1
Garage door

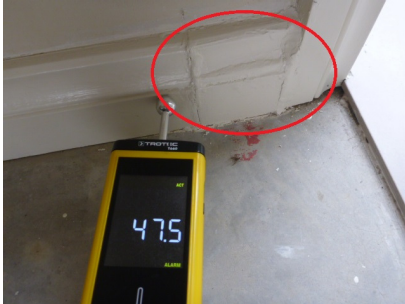
Painted gib and ceramic tiles. There is a small area of skirting board that has patched up beside the back door. Unsure what has happened here. Moisture Meter readings only slightly elevated. Reading 47 approx. 20%	2
Ceiling

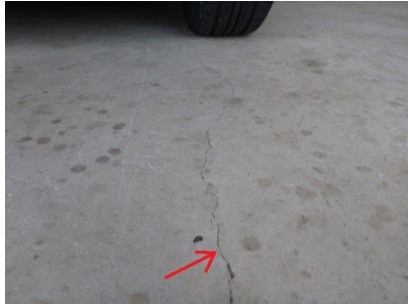
Concrete. There is a hairline crack in the concrete. This is minor and acceptable	3
Windows

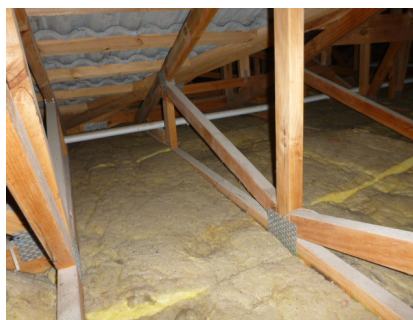
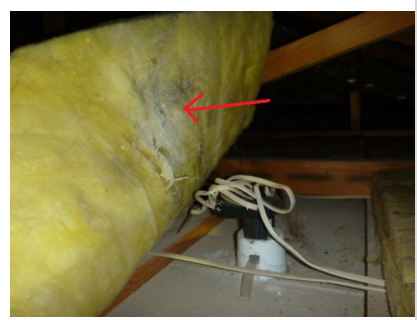
Gold Batts installed. Insulation is covering some of the lights and heat marks are seen, recommend clearing away	2,3
Insects and Pests

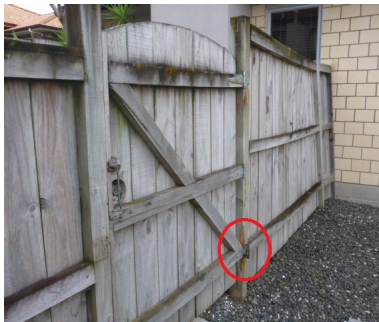
Timber paling 1 gate hinge has come off	1
Paths/Driveways
