Sample Report

Property address Drury

Inspection date 2/5/12

Property description Split level, 4 bedroom, 2 bathroom, brick cladding, pressed metal tile roof house

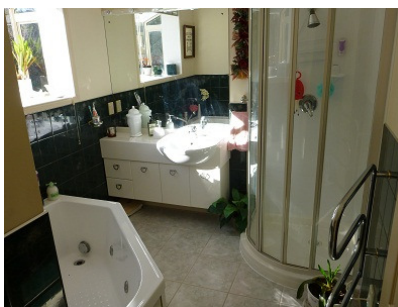
Flick mixer type, work ok. The bathroom shower head connection in the wall turns when you try to adjust the shower head, this shouldn't happen. It does not leak	2

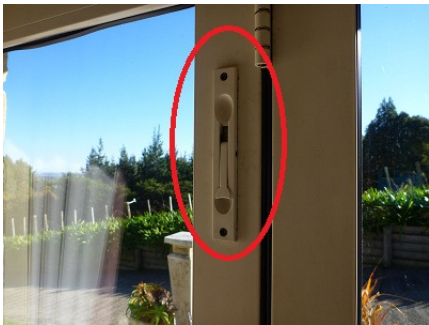
Bi-fold doors. 1 bifold door latch it very hard to operate, may just need CRC to ease	2
Walls

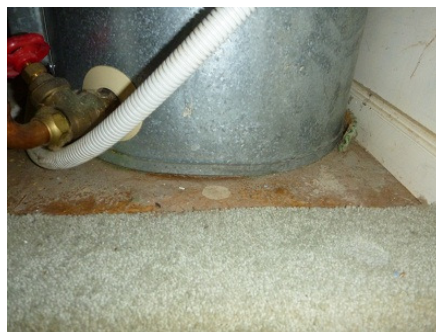
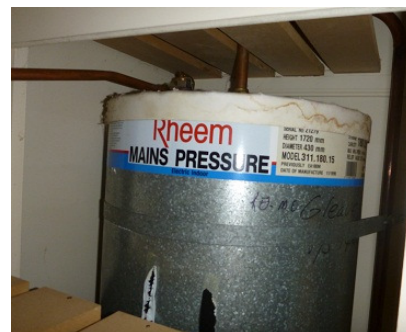
180L mains pressure cylinder. No sign of any leaks. Age=16yrs	2,3
Switchboard				Not sighted	
Smoke detectors

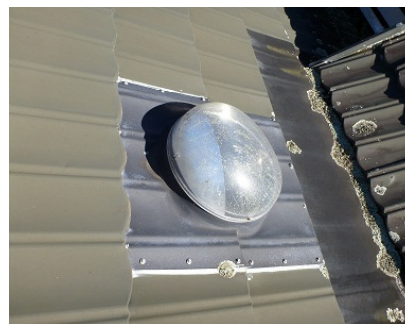
Photo three

Pressed metal tile in good condition. Needs cleaning in as places as Lichen is heavily built-up	2
Roof slope

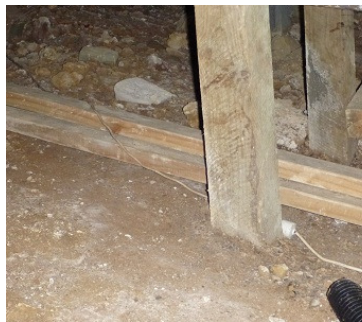
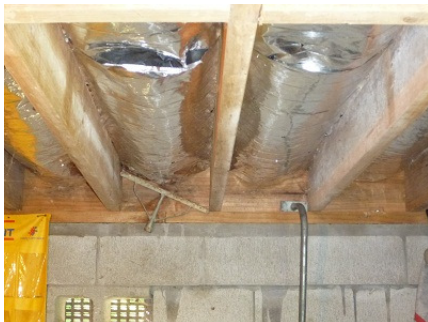
Additional notes					
There was some polythene laid over some of the dirt, photo 3. Being flat water can sit there and this prevents rising
