**76 Gracechurch Dr,
Flat Bush**

Inspection date 6/5/16

Property description 2 storey, 5 bedroom, 4 bathroom, brick and plaster cladding, concrete tile roof house

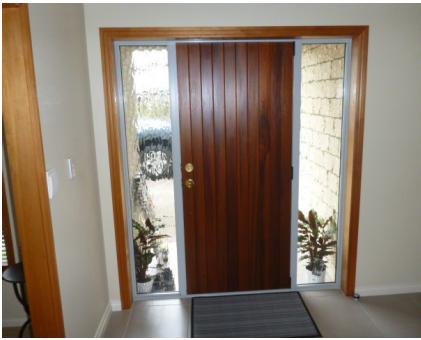
Entrance and Hallway					
	●	●	●	Details	Photo ref
Front door	●			Timber door, in good condition and works ok.	2
Walls	●			Painted gib	
Ceiling	●			Painted gib	
Floor coverings	●			Ceramic tiles	
Cupboard doors				Nil	
Windows	●			Fixed glass	
Photo one		Photo two		Photo three

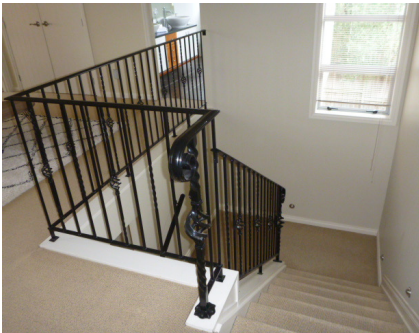
Iron handrails and balustrade, all secure	2
Photo one			Photo two		Photo three

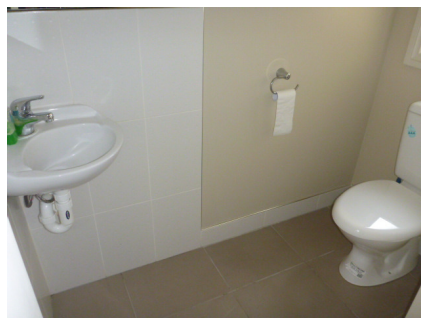
Photo two

Small hand basin installed. All taps and fittings checked and are in good working condition	2

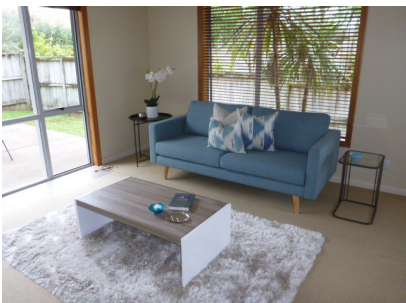
All work ok. 1 restrictor stay has come loose on a window, needs re-installing	1
Heating				Gas fire, not tested	
Photo one		Family		Lounge

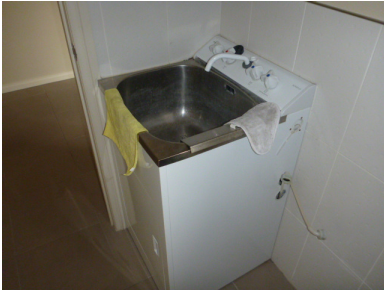
Photo four

The laundry is located in the garage in which a Supertub is installed and is in good condition, photo 4. All taps and fittings checked and are in good working order

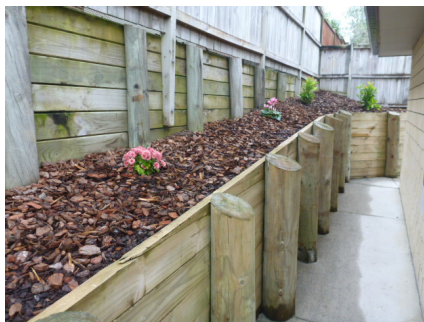
Timber retaining walls, in good condition	2
Letter box

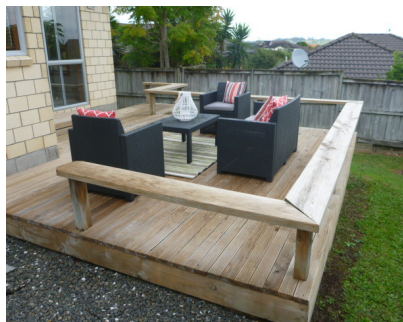
Additional notes					
1 small timber deck has been erected off the dining room and is in good condition. Photo 3
